**Flood Control Project Maintenance  
Levee Inspections****LMA District Cover Sheet****Spring 2013 Levee Inspection Results****Reclamation District No. 0536 Egbert**

**Levee Inspection Report By Mile - Spring 2013**

**Reclamation District No. 0536 Egbert**

Waterway	Bank	Unit Miles	Inspection Start/End	Inspector
Unit No. 01 Lindsey Slough	Right	5.66	04/11/2013 04/11/2013	Herman Phillips

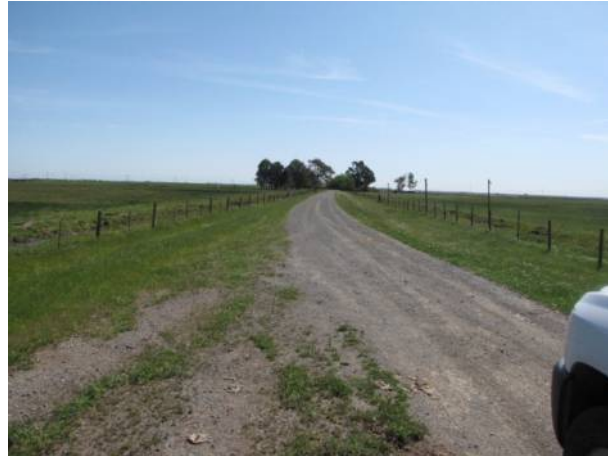
Levee Mile Report Line	4
Start Levee Mile	0.00
End Levee Mile	0.00
Location	Land Side
Category	
Item	Vegetation
Looking upstream from levee mile 0.00 unit 1 RD 536. Photo taken 4-12-2013.	
phillips_s_20130520_448.JPG

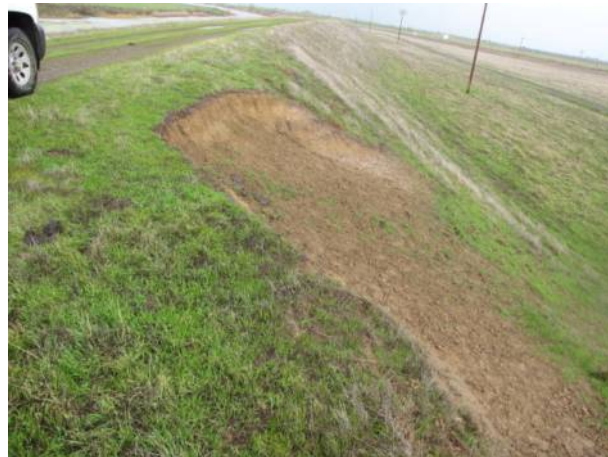
Levee Mile Report Line	9
Start Levee Mile	0.74
End Levee Mile	0.75
Location	Land Side
Category	
Item	Erosion / Bank Caving
This erosion was noted in prior inspections during the spring of 2011 and the spring of 2012. Photo taken 11-28-2012. This site hasn't changed, it still looks the same. No new photo was taken 4-12-2013.	
phillips_s_20130325_303.jpg

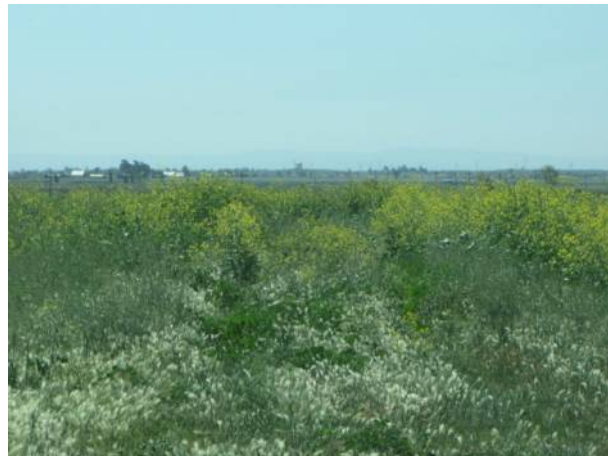
Levee Mile Report Line	22
Start Levee Mile	2.80
End Levee Mile	5.00
Location	Crown
Category	
Item	Vegetation
Levee mile 2.80-5.00 crown roadway severely overgrown and weeds on both slopes are taller than 4-foot. Photo taken 4-12-2013.	
phillips_s_20130522_449.JPG

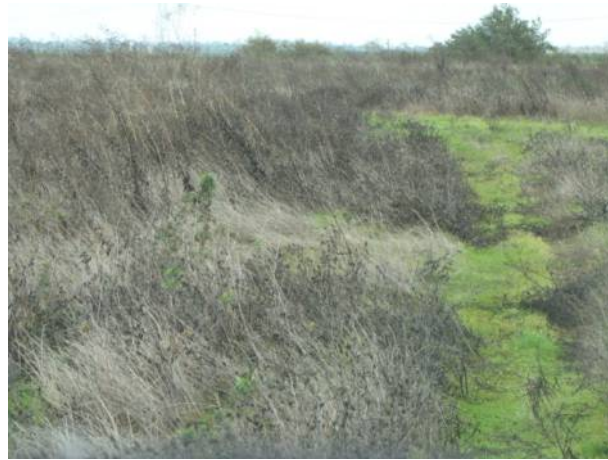
Levee Mile Report Line	24
Start Levee Mile	3.38
End Levee Mile	3.77
Location	Water Side
Category	
Item	Vegetation

RD 536, wild growth on waterside of levee section, can't see the slope. Photo taken 11-28-2012.

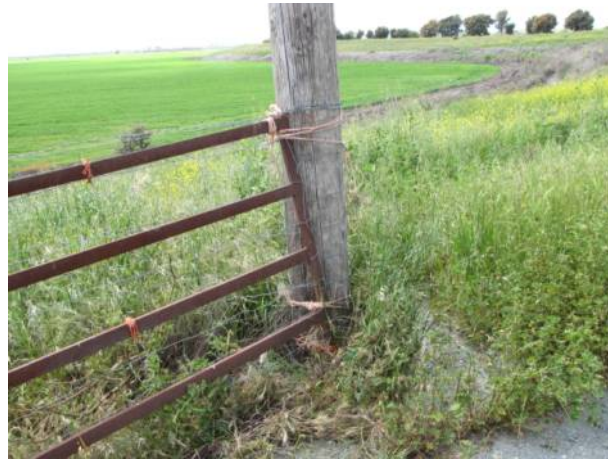
Levee Mile Report Line	26
Start Levee Mile	3.68
End Levee Mile	3.68
Location	Water Side
Category	
Item	Repair Gates

Repair this gate. Someone could get hurt trying to open and close this gate. 4-24-2012. No new picture was taken, no change to this gate. 4-12-2013.

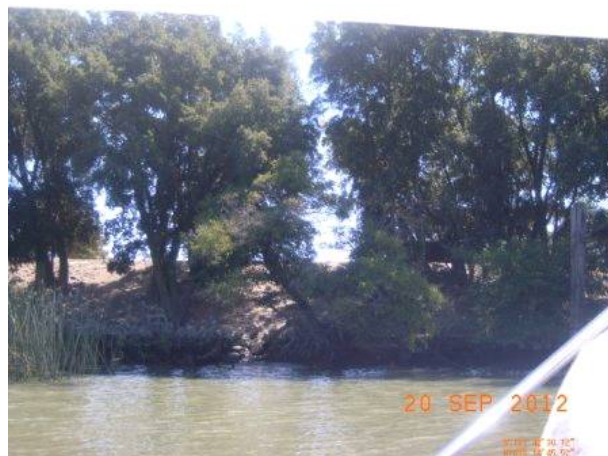
Levee Mile Report Line	33
Start Levee Mile	4.94
End Levee Mile	4.96
Location	Water Side
Category	Supplemental
Item	USACE Erosion Survey

USACE 2012 Photo #1

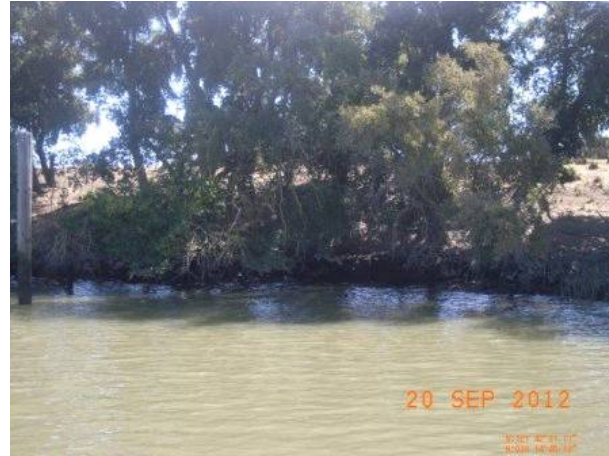
Levee Mile Report Line	33
Start Levee Mile	4.94
End Levee Mile	4.96
Location	Water Side
Category	Supplemental
Item	USACE Erosion Survey

USACE 2012 Photo #2

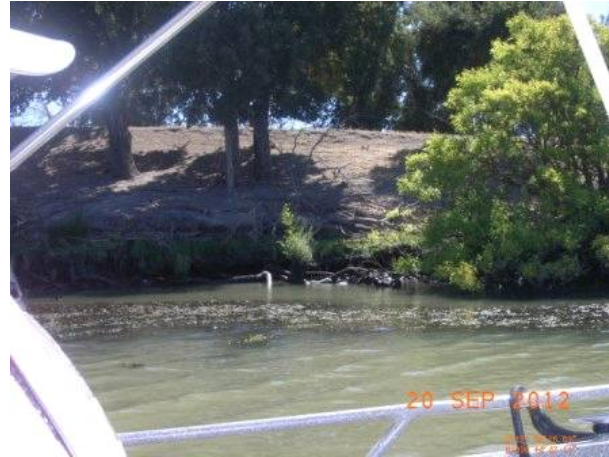
Levee Mile Report Line	34
Start Levee Mile	4.99
End Levee Mile	5.04
Location	Water Side
Category	Supplemental
Item	USACE Erosion Survey

USACE 2012 Photo #1

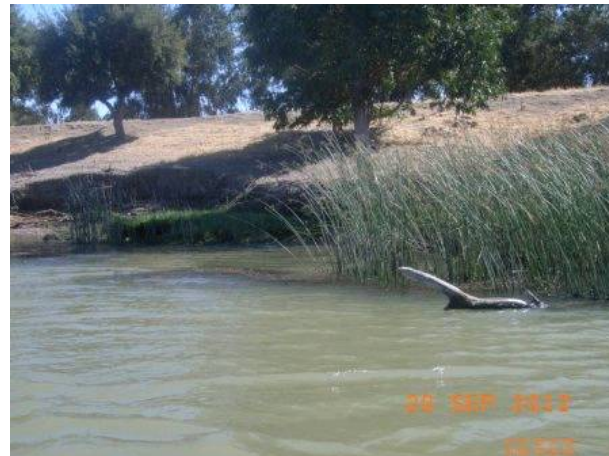
Levee Mile Report Line	34
Start Levee Mile	4.99
End Levee Mile	5.04
Location	Water Side
Category	Supplemental
Item	USACE Erosion Survey

USACE 2012 Photo #2

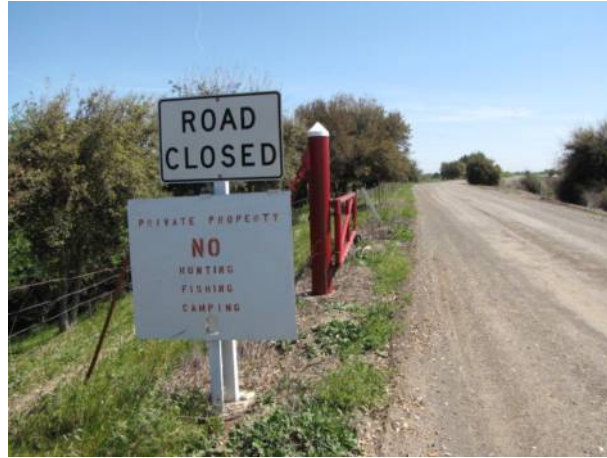
Levee Mile Report Line	38
Start Levee Mile	5.39
End Levee Mile	5.39
Location	Crown
Category	
Item	Encroachments

This gate at levee mile 5.39 was installed with a CVFPB Permit. Photo taken 4-12-2013. This closure was installed prior to the fall inspection 2012.

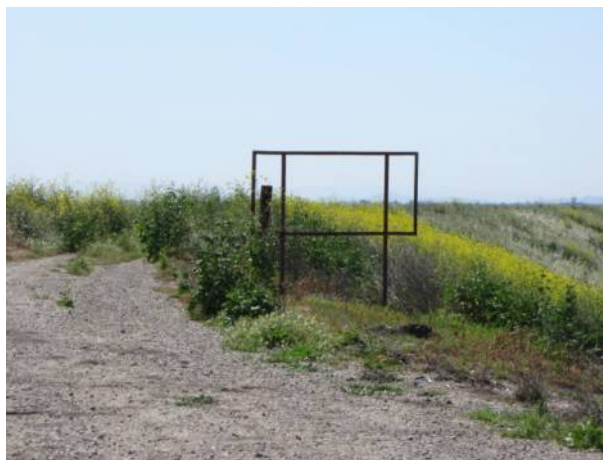
Levee Mile Report Line	1
Start Levee Mile	0.00
End Levee Mile	4.91
Location	Land Side
Category	
Item	Vegetation

RD 536 Looking downstream from levee mile 0.00. Unsatisfactory wild growth greater than 2-foot on levee section on both slopes and crown roadway. Photo taken 4-12-2013.

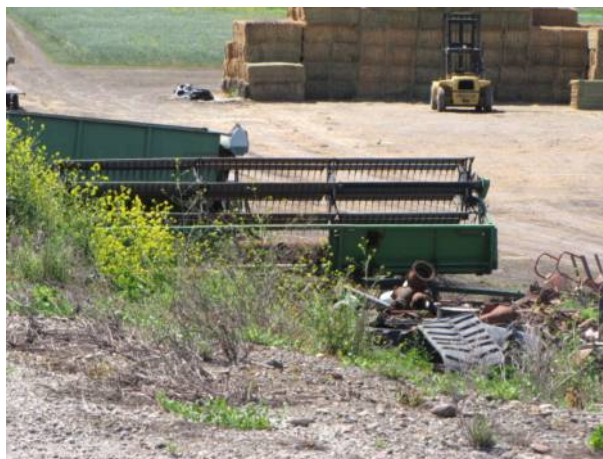
Levee Mile Report Line	2
Start Levee Mile	0.01
End Levee Mile	0.06
Location	Land Side
Category	
Item	Encroachments

Equipment placed on landside easement Unit 2. Photo taken 4-12-2013.

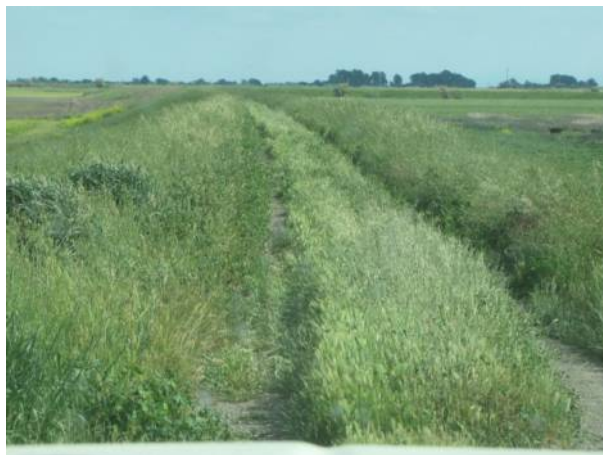
Levee Mile Report Line	11
Start Levee Mile	2.22
End Levee Mile	2.98
Location	Crown
Category	
Item	Crown Surface / Depressions / Rutting

Looking downstream along levee mile 2.22-2.95 at the crown roadway. Photo taken 4-24-2012. During the spring inspection, 4-12-2013, no maintenance has been done on the levee section. Looks the same.

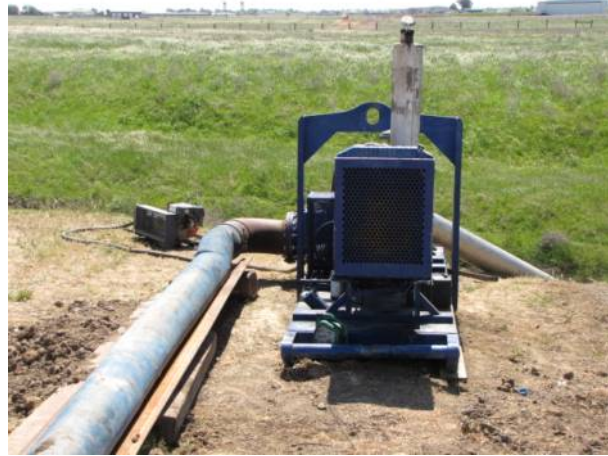
Levee Mile Report Line	18
Start Levee Mile	4.26
End Levee Mile	4.26
Location	Crown
Category	
Item	Encroachments

DWR ID: DWR_RD0536_02_s_2013_3										
18	4.26	4.26		Encroachments	CR	M En	PI : Pipe Inspector Comments: There is no permit for thhis pipework. The owner is the District's President Mr. Page Baldwin.	38.196406 ° -121.698410 °	38.196406 ° -121.698410 °	7 Y
DWR ID: DWR_RD0536_02_s_2013_7

Equipment and diesel pump placed on the water ward slope and shoulder of unit 2. Photo taken 4-12-2013.

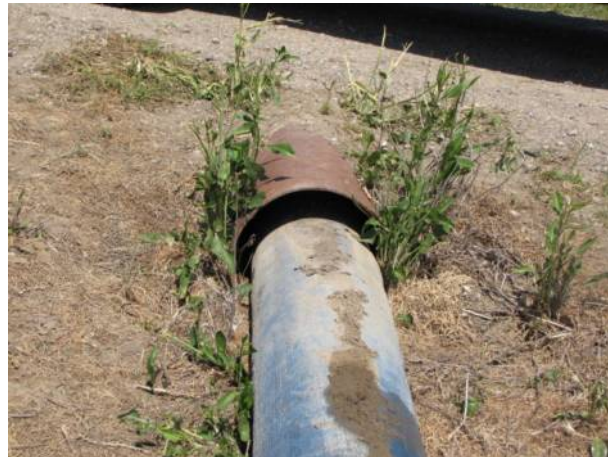
Levee Mile Report Line	18
Start Levee Mile	4.26
End Levee Mile	4.26
Location	Crown
Category	
Item	Encroachments

This is another view of the pipe through levee.
